Automatic Transmission

SERVICE GUIDE

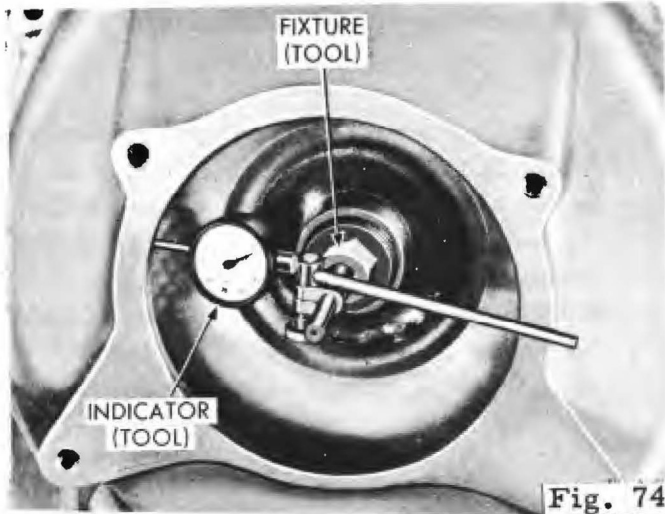
- ⊗ Locate the indicator so that it is bearing on the transmission pilot bore of the converter housing. Rotate the converter.
- ⊗ The runout must not exceed .010" total indicator reading.
- ⊗ To illustrate the recommended correction procedure, assume that the total indicator reading is .016", in a direction which approximates 2 o'clock on engine block. (Fig. 75). In this case, the housing is off crankshaft centerline .008" (one-half total indicator reading) which is .003" greater than the allowable limit of .005" (one-half total indicator reading).

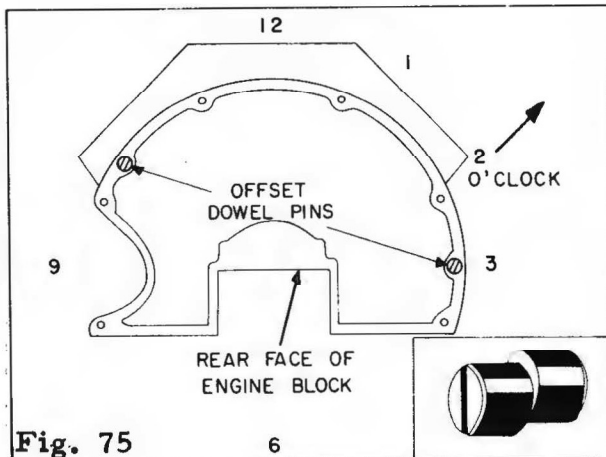
- ⊗ To correct an off-center condition, 3 off-set dowels are available.

When selecting dowels to be used for a particular job, take the dowel closest to one-half the total indicator reading. Refer to the chart.

In the case under consideration, use of the .007" offset dowels (pair) will bring the runout well within the allowable limit of .005", or .008" minus .007" (offset dowels) equals .001" runout.
